Intensity of Coastal Erosion in Sri Lanka: The Case of South Western Coastal Sector

A.G. Amarasinghe, (PhD, M.Phil. B.A. (sp), Certi. in Geology) Senior Lecturer, Department of Geography, Faculty of Social Sciences, University of Kelaniya, Sri Lanka,

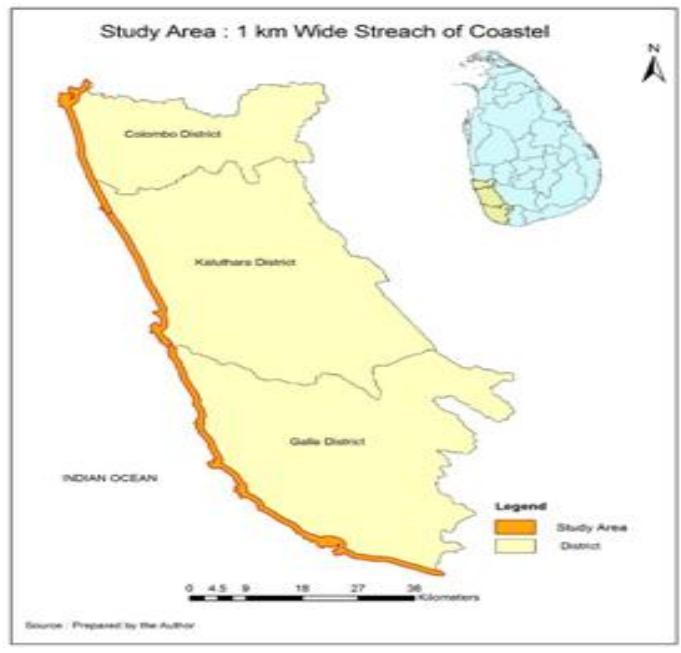
Figure 01

Coastal Zone extends from Colombo to Galle is defined as the Southwestern coastal sector (CCD,1986, Maddumabandara, 1989). Northern end of this coastal sector is Colombo Lighthouse and the Southern end marks by the Matara - Galle district boundary. Coastal zones of three districts namely, Colombo, Kaluthara and Galle of the Western Province comprised with the study area. The total length of the SW coastal sector is 155Kms. This is 10% out of total length of the Sri Lanka's coastline. There were 14 districts and 67 divisional secretariats covering the coastal region with maritime boundaries in Sri Lanka. South Western coastal sector comprised with three districts and 13 DSDs (Figure 01).
